Environmental Assessment Worksheet

Grantee	Nelson Park Preservation Associates, LLC
Grant Number	N-B-22-9AA-1-22-0267
Activity Name	Nelson Park Apartments
Activity Location	1994 Maryland Avenue, Columbus, Franklin County, Ohio (43219)
The project involves the renovation of an existing 177-unit senior and multi-family apartment complex to create 56 senior and 84 multi-family housing units, and the adaptive reuse of three existing apartment buildings to create a new community building, new management offices, and a new maintenance garage	
Determination: <input checked="" type="checkbox"/> <u>Finding of No Significant Impact (FONSI)</u> , whereby the Responsible Entity may proceed to Dissemination and publication of the FONSI, per regulations found at 24 CFR Section 58.43(a). <input type="checkbox"/> <u>Finding of Significant Impact</u> , whereby the Responsible Entity must proceed to develop an Environmental Impact Statement (EIS) in compliance with 24 CFR Part 58, Subparts F or G.

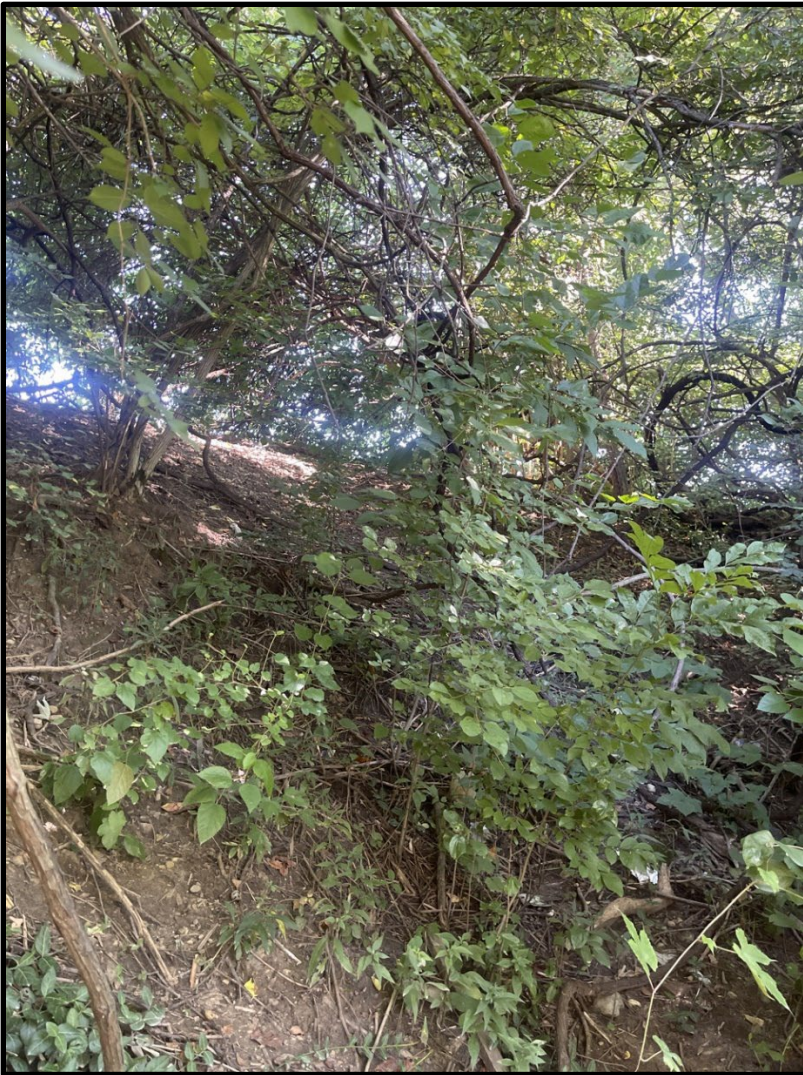
Hazards and Nuisances Including Site Safety and Noise	Requires Mitigation	Steep slopes are present on the project site. An existing retaining wall made of repurposed railroad ties was failing at the time of the site visit. The project plans to replace the existing retaining wall with a stone retaining wall with the height to match the existing. A large portion of the slope and retaining wall is buffered by scrub/shrub

10. View of existing dilapidated retaining wall to be replaced within the project site, looking north.

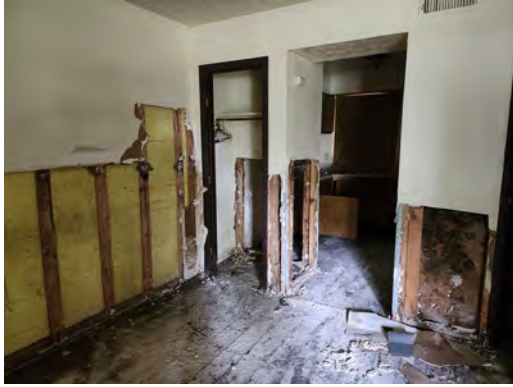
PHOTO #25 RESIDENTIAL UNIT WITH SUBSTANTIAL WATER DAMAGE

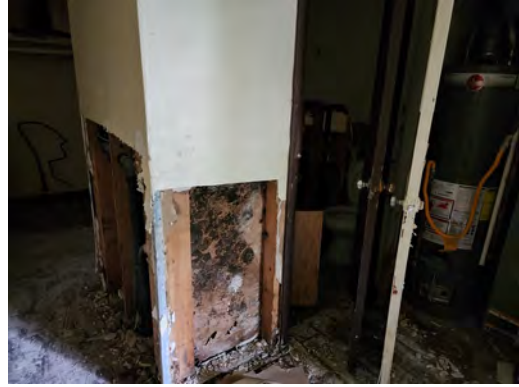
PHOTO #26 MOISTURE INTRUSION AND SUSPECT MOLD

18. During construction, all project units and common areas shall be examined for indoor mold on all surfaces that are exposed either on a regular basis or by the project scope of work. The cause of any identified mold shall be determined and corrected as part of construction, and all mold shall be remediated.

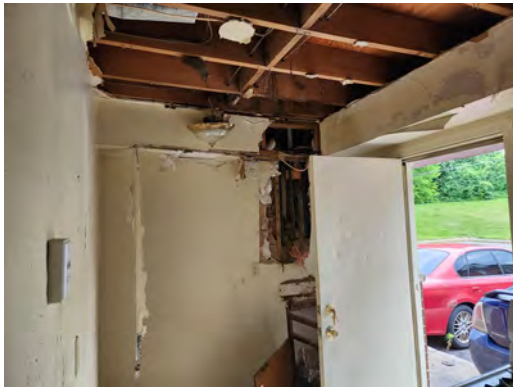
PHOTO #27 WATER DAMAGE
