Environmental Assessment Worksheet

Grantee	Nelson Park Preservation Associates, LLC
Grant Number	N-B-22-9AA-1-22-0267
Activity Name	Nelson Park Apartments
Activity Location	1994 Maryland Avenue, Columbus, Franklin County, Ohio (43219)
The project involves the renovation of an existing 177-unit senior and multi-family apartment complex to create 56 senior and 84 multi-family housing units, and the adaptive reuse of three existing apartment buildings to create a new community building, new management offices, and a new maintenance garage	
Determination: <input checked="" type="checkbox"/> <u>Finding of No Significant Impact (FONSI)</u> , whereby the Responsible Entity may proceed to Dissemination and publication of the FONSI, per regulations found at 24 CFR Section 58.43(a). <input type="checkbox"/> <u>Finding of Significant Impact</u> , whereby the Responsible Entity must proceed to develop an Environmental Impact Statement (EIS) in compliance with 24 CFR Part 58, Subparts F or G.

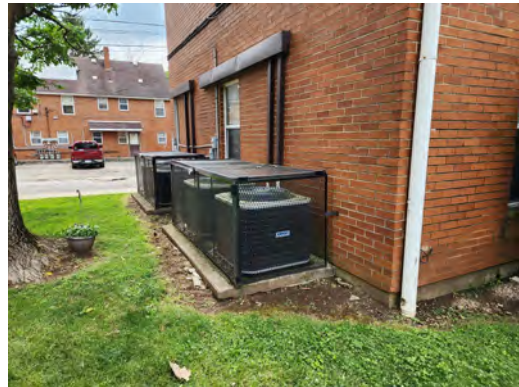
PHOTO #28 AIR CONDITIONING UNITS
